# DRAFT BASIC ASSESSMENT REPORT

PROPOSED FOUR (4) TWO-BEDROOM SELF-CATERING  
ACCOMMODATION UNITS ON PORTION 9 OF FARM 707  
OSBOSCH, KOUGA LOCAL MUNICIPALITY  
HUMANSDORP REGISTRATION DIVISION, SARAH  
BAARTMAN DISTRICT MUNICIPALITY, EASTERN CAPE.  
REF NO: EC08/C/LN1&3/M/30-2026

PREPARED BY  
ADEKITE CONSORTIUM OF  
ENVIRONMENTAL SPECIALISTS

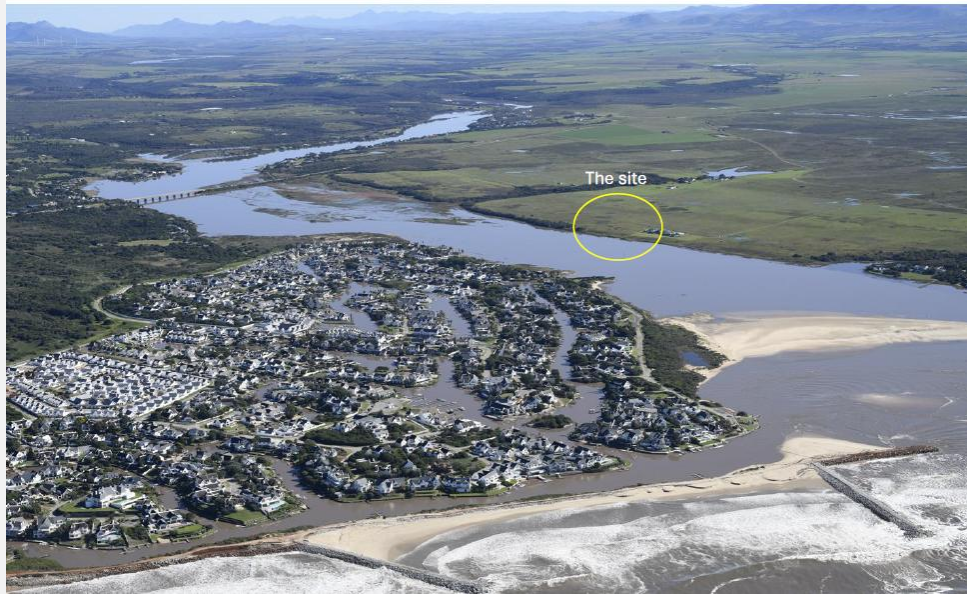
FIGURE 22 AERIAL PHOTOGRAPH OF THE KROMME ESTUARY ON THE 9TH OF MAY 2026, POST SEVERE STORM EVENT

Historical aerial imagery and recent observations post recent storm events indicate that high-water levels remain contained within the estuarine channel and associated riparian margins, with no evidence of flooding extending near or into the proposed development area. See **Appendix A7 for historical aerial imagery** and aerial imagery post May 2026 low-pressure storm, and June storm, which caused a significant rise in water levels and local flooding in the surrounding areas. The second storm event, which occurred on 3 June 2026, followed the severe May storm that had already filled the local dams. Despite these antecedent conditions, no water entered the site during the June event.

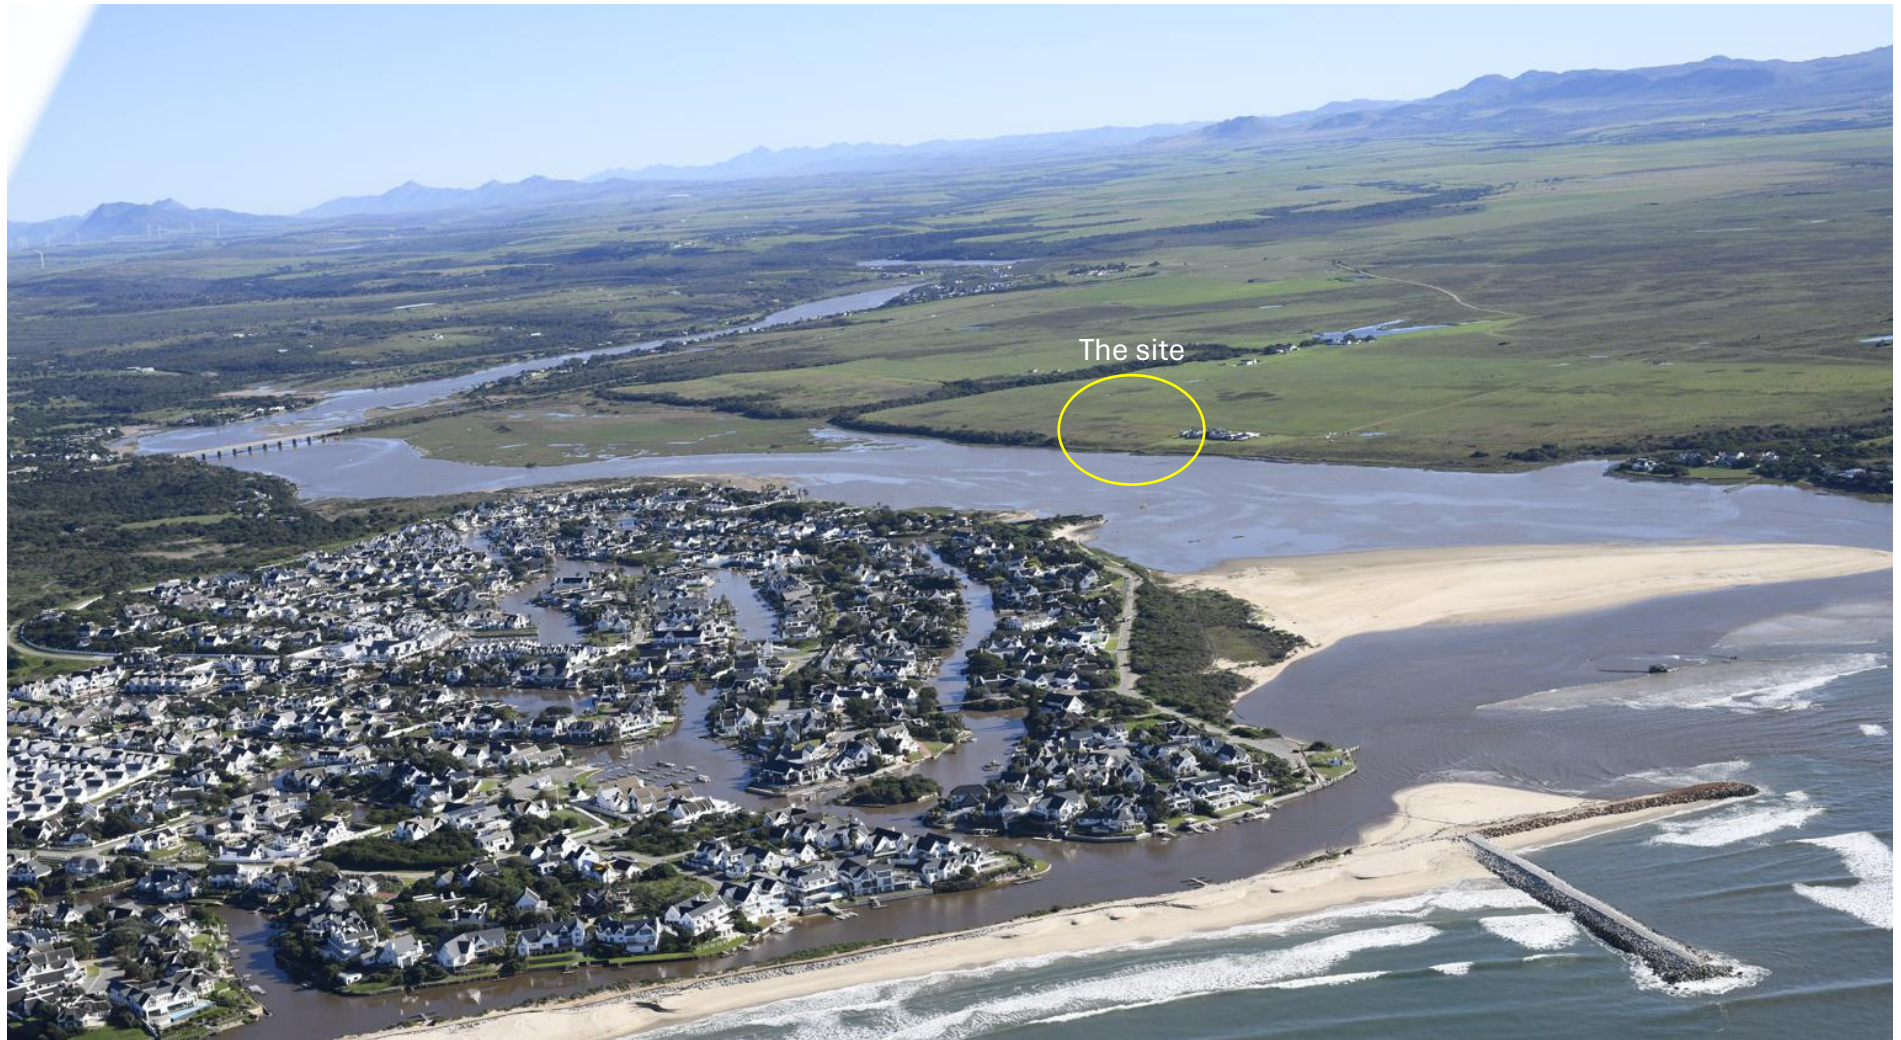
**Post June 3rd – 4th storm** – Taken 10 June 2026 10:37. (Source: South African Estuary Information System (SAEIS – SAEON))

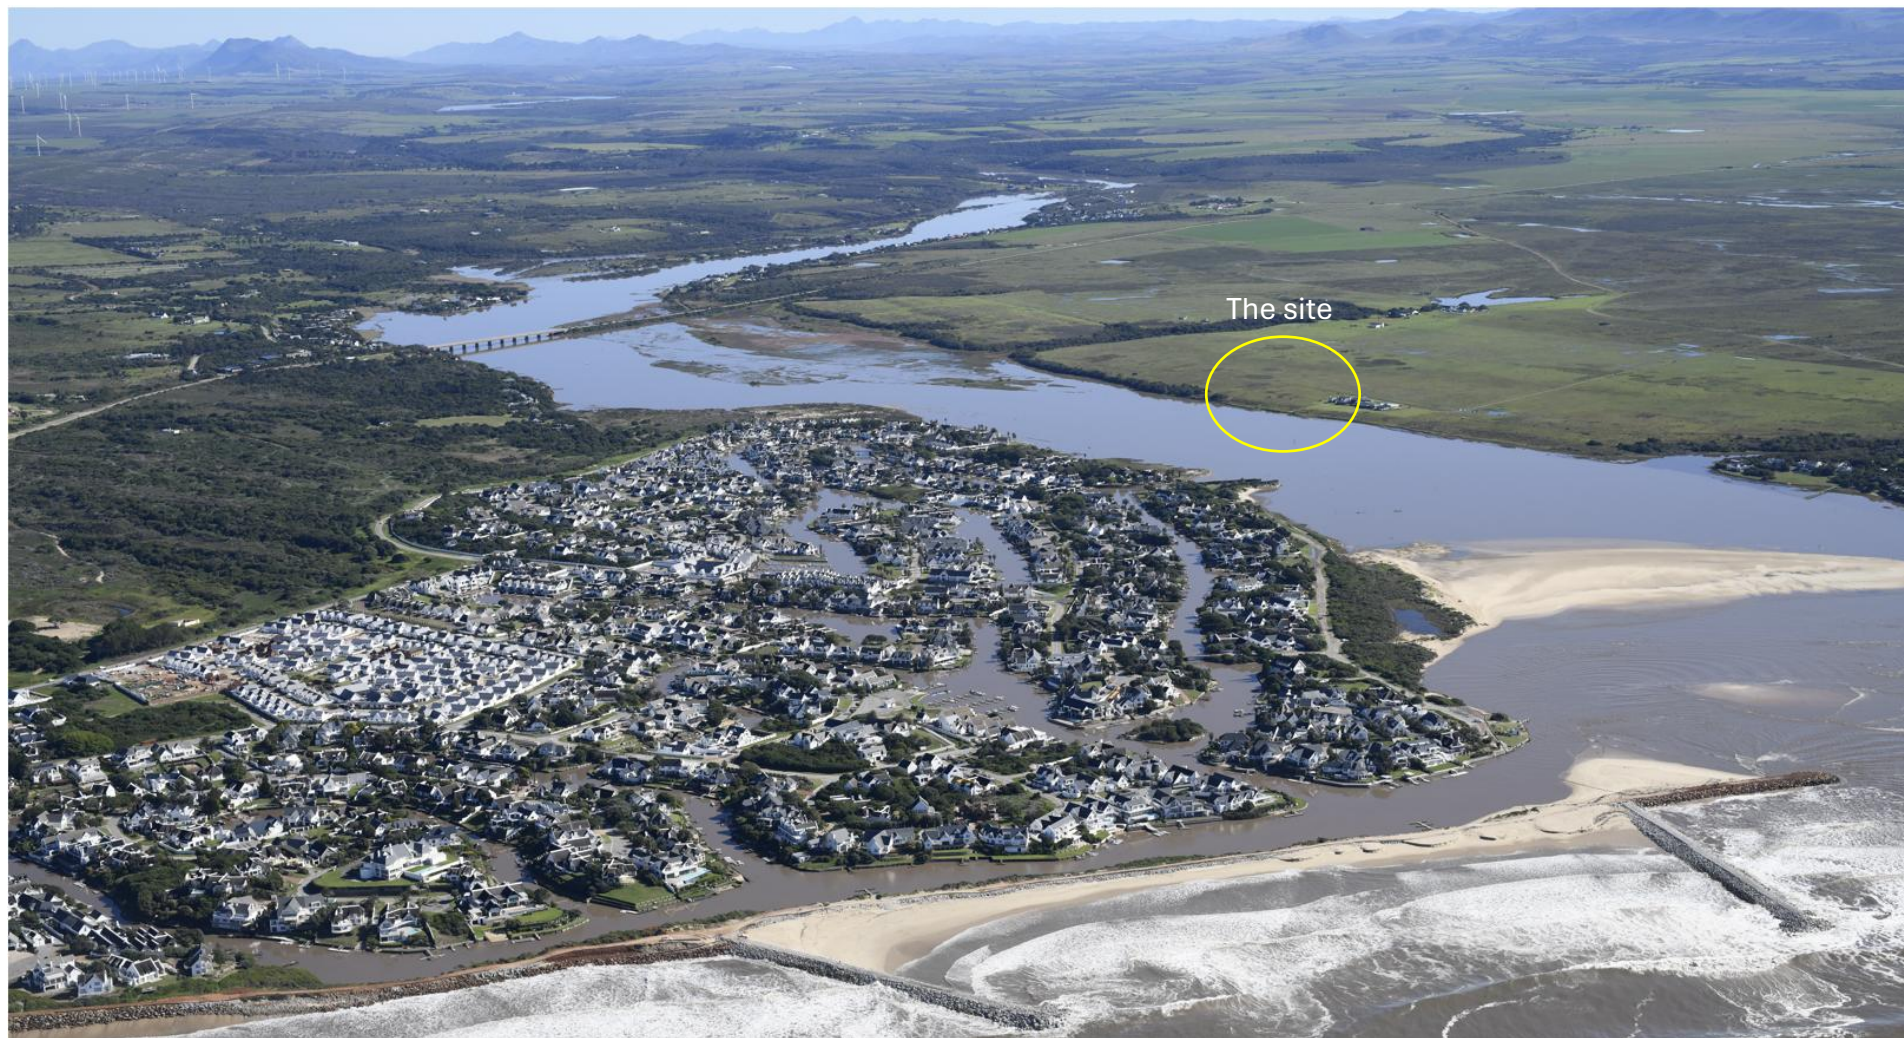
**Post May 5<sup>th</sup> – 7<sup>th</sup> Low pressure system storm** – Taken 09 May 2026 11:00. (Source: South African Estuary Information System (SAEIS – SAEON))

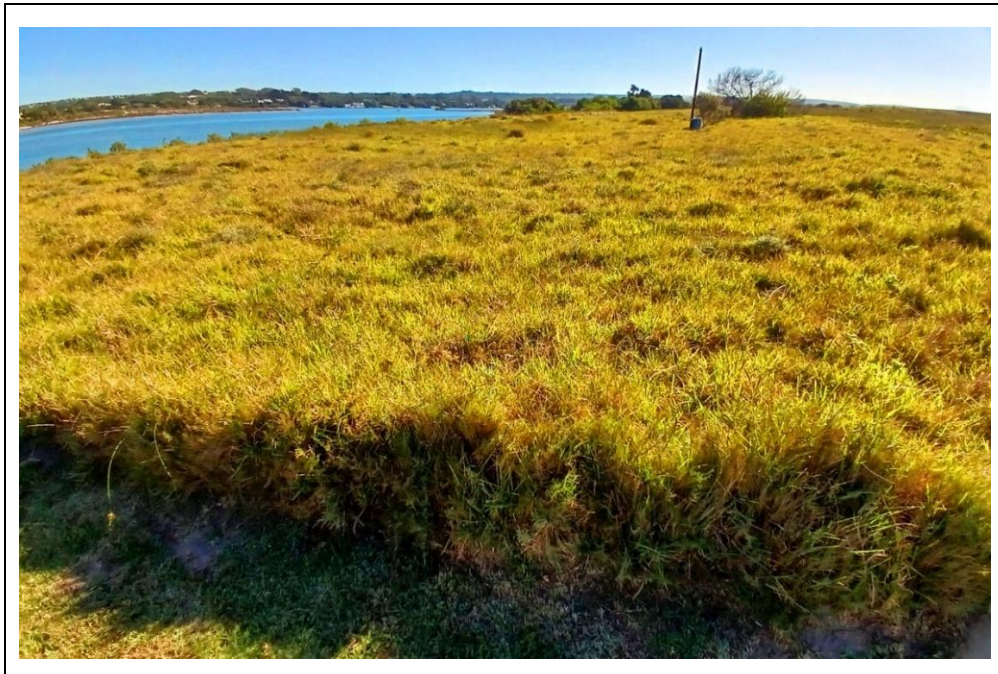
Ptn 9 Osbosch covers a total area of 7185m<sup>2</sup> and has an average slope of 2,0% in a southerly direction towards the Kromme river. It has a thick grass cover, and its geology consists mainly of loose sandy soil. **Illustration 2** below is a general view of the property.

**Illustration 2 – General View of Ptn 9 Osbosch707.**

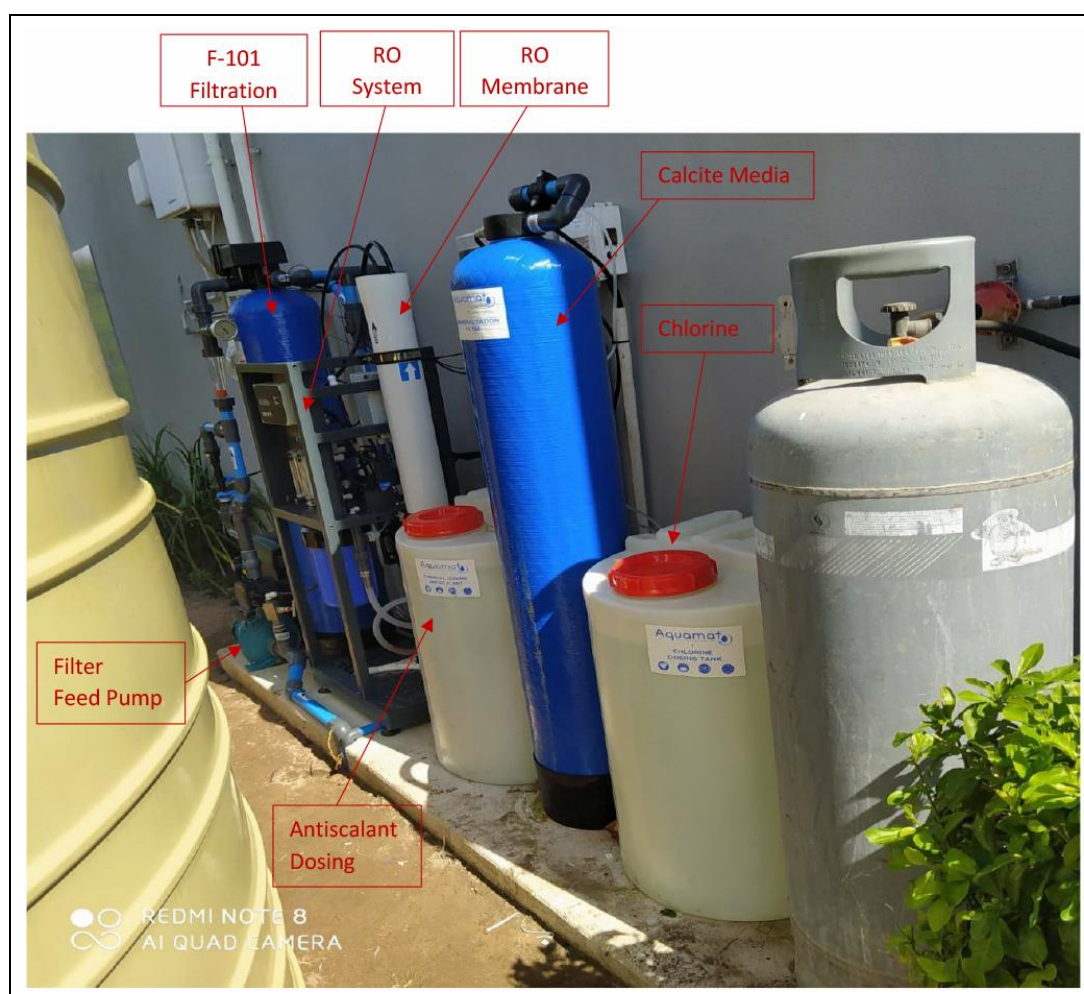
The on-site water treatment system is designed for the purification of borehole water to meet potable water standards. The treatment process includes pre-sterilization with ozone disinfection, sediment and heavy metal removal filtration, anti-scalant dosing, cartridge filtration and reverse osmosis (RO) separation, calcite remineralization and product water sterilization using chlorine.

**Illustration 5 – Proposed Water Treatment System.**

**Illustrations 5 & 6** below show details of the water treatment system. The document containing the full details of the system is available upon request.

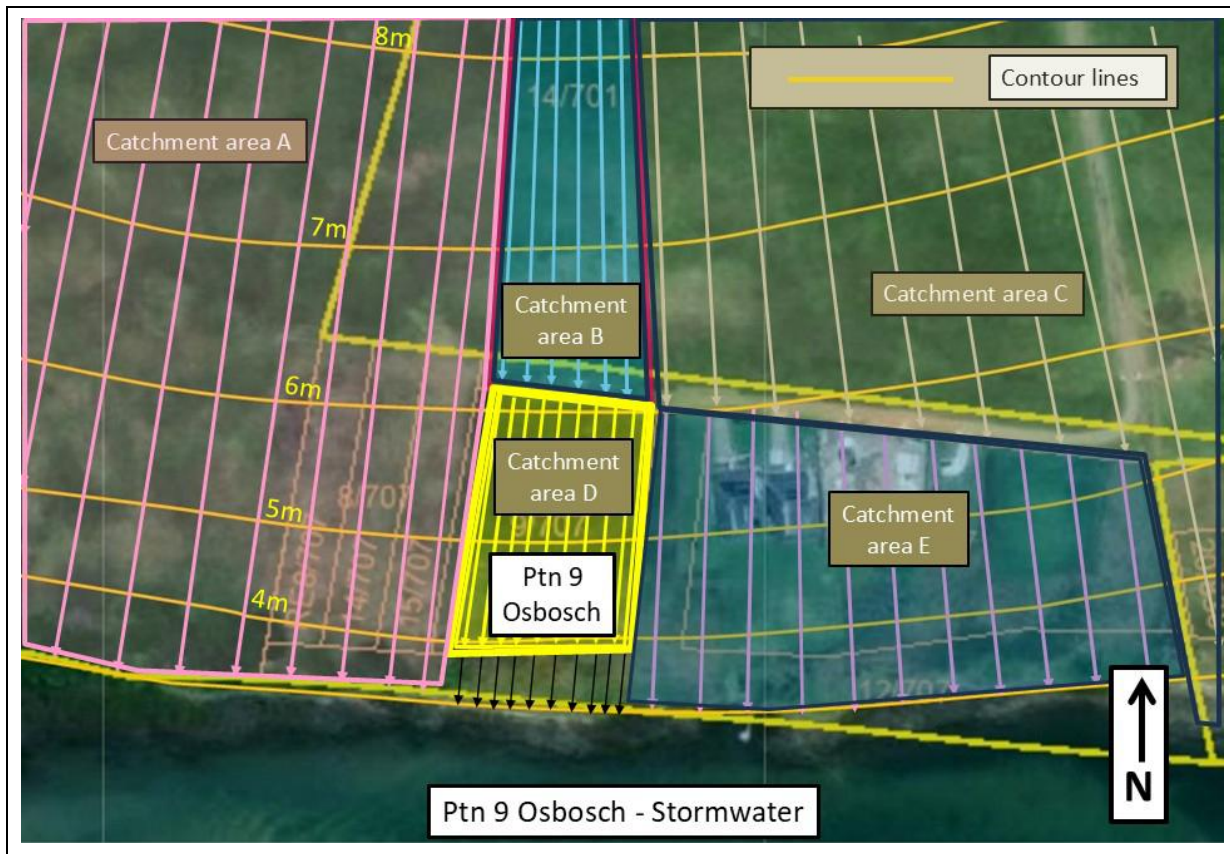
A comprehensive stormwater evaluation was done for Ptn 9 Osbosch with **Illustration 9** below showing the catchment areas in the vicinity of Ptn 9 Osbosch, used for the run-off calculations. **Table 10** below reflects the calculated maximum flow rates (in litres per second) for four different return periods (See also **para. 7.5.5** below for proposals on handling of the stormwater on this site):

**Illustration 9 – Stormwater Catchment Areas in vicinity of Ptn 9 Osbosch.**

**Table 10** below presents the anticipated stormwater flows for return periods of 5, 20, 50, and 100 years, respectively. It indicates that the peak stormwater flow for a 1:100-year flood event is estimated to be approximately 67 litres per second. This figure is considered relatively low in the context of general stormwater flow rates and can be efficiently managed using a pipe with a diameter of 300mm.

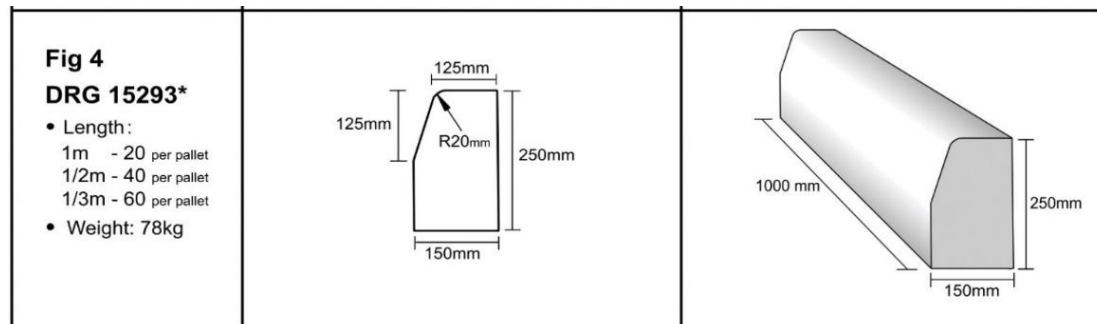
- For the first protection, all stormwater collected from the paved areas will be guided by means of Figure 4 barrier kerbs on the southern edge of the paving towards grid inlets at four low points at each of the dwellings (See **Illustrations 10 & 11** below).
- From the grid inlets the stormwater will be conveyed in a piped stormwater system past the dwellings in a southerly direction, where it will be released on the grassed surface towards the river.
- A total of 4 x 160mm diameter stormwater pipes would be sufficient to deal with a 1:50 year recurrence maximum flood.

**Illustration 10 – Figure 4 Barrier Kerb.**

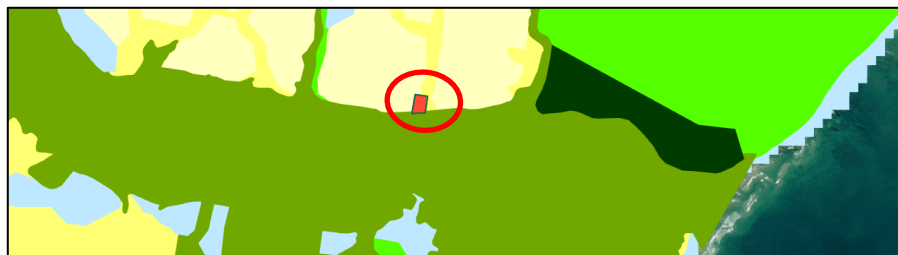
On the ECBCP map, the site is on the boundary of the marine environment to the south (CBA - green area) which is classified as a “natural coastal zone”. The dark yellow mapped areas represent the ESA areas which are classified as “important natural catchment zones”. The ESA on the study site represents a seep zone that gather water from the landscape, draining from the north towards the estuary. The water is transported to the estuary (subsurface) during the wet season, and it is important to note that runoff water from the site and the development will impact on the receiving environment. The light-yellow sections on site are mapped as “not natural” and is classified as previously cultivated fields (SNABI BGIS ECBCP, 2019).

Figure 1.3: The site is adjacent to the CBA (green zone) associated with the marine environment and the dark yellow mapped zone represent the ESA area, listed as important natural catchment zones. The light-yellow sections on site are mapped as “not natural” – fields (SANBI BGIS ECBCP, 2019).

During the terrestrial assessment the only freshwater resource noted was the seasonal seepage zone. This natural drainage system is reflected as part of the landscape drainage of water into the estuary. Water drains from the catchment through the sandy soil profile (subsurface) into the marine environment (Figure 1.3).

During the field assessment, the vegetation composition on site indicated some wet conditions during the rainy season. The plants are present and is related to the shallow water table on site. This is the water accumulated in the catchment that moves through the soil profile south towards the estuary (seep area – Figure 1.3).

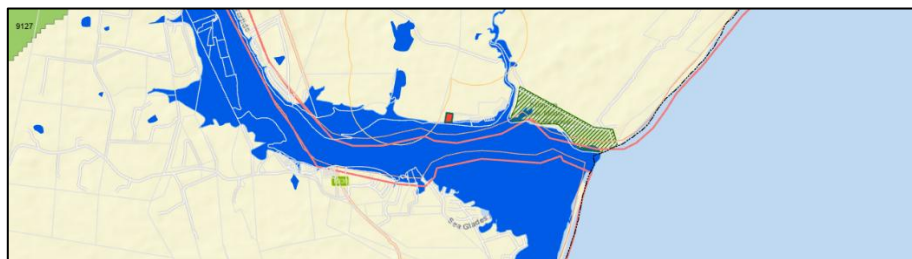
in the seep zone and pollution (sewage, chemicals, pesticides, oil and fuel) from the site. In Figure 1.5, the Freshwater Ecosystem Priority Areas (FEPA) layer (SANBI BGIS, 2025) is depicted. The site is near the estuary (downstream wetland) and a wetland seep area that drains the landscape from the north. The development will impact on the subsurface flows in the seep zone that drains water from the catchment into the estuary.

Figure 1.5: The Freshwater Ecosystem Priority Areas (FEPA) map of the site indicating aquatic resources downstream of the site, the estuary rated with a sensitivity of "very high". The estuary will be impacted by the development (very limited) (SANBI BGIS, 2025).

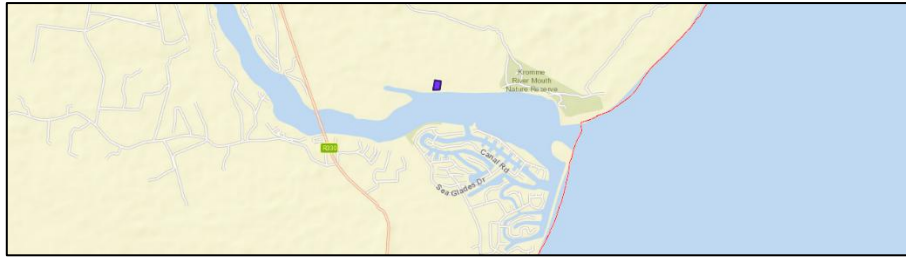
Figure 1.6 reflect the Strategic Water Sources Areas (SWSA) layer. On the map, there is no aquifer that will be impacted by the development (SANBI BGIS, 2025).

Figure 1.6: The Strategic Water Sources Areas (SWSA) map of the site indicating no aquifer that will be impacted by the development (SANBI BGIS, 2025).

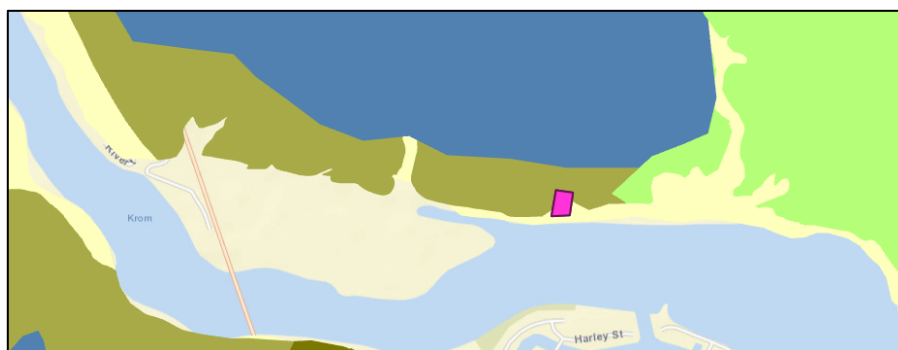
The STR map (Figure 1.7) shows the **low/medium sensitivity** for the site (DFFE, 2025) and the two regional vegetation types present are the **Elands Forest Thicket (AT 26)** and the **Albany Alluvial Vegetation (Aza 6)**. Other vegetation units present in the area are the Sundays Mesic Thicket (AT 50), the Humansdorp Shale Renosterveld (FRs 19) and the St Francis Dune Thicket (AT 57) (Mucina and Rutherford, 2018) (Figure 1.8).

Figure 1.8: The site is associated with the Elands Forest Thicket (brown) and the Albany Alluvial Vegetation (yellow) with the Sundays Mesic Thicket (light green to the east), the Humansdorp Shale Renosterveld (dark blue to the north) and the St Francis Dune Thicket (dark green south of the estuary) (Mucina and Rutherford, 2018).

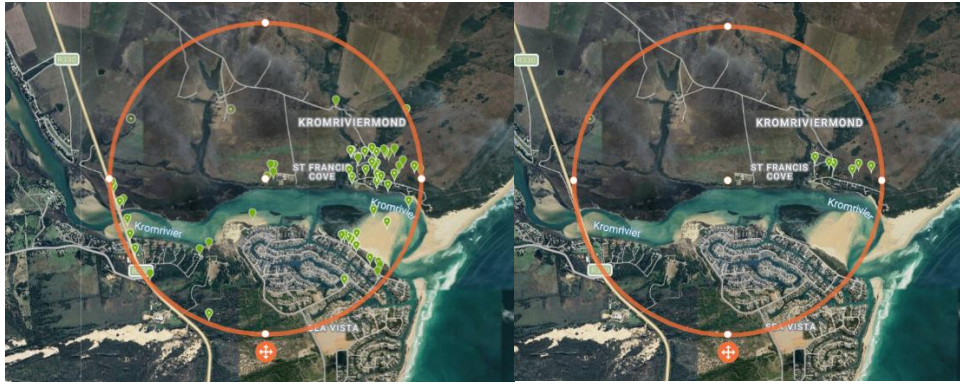
In Figure 1.9, maps are depicted of a 3 km radius from the site with all plants recorded and red data plants observed in iNaturalist (2025). In Table 1.5 all plants observed with its status is reflected and Table 1.6 is an extract of the red data plants recorded (iNaturalist, 2025).

Figure 1.9: The map of a 3 km radius with “all plants” recorded on the left and “red data plants” recorded on the iNaturalist platform (2025).

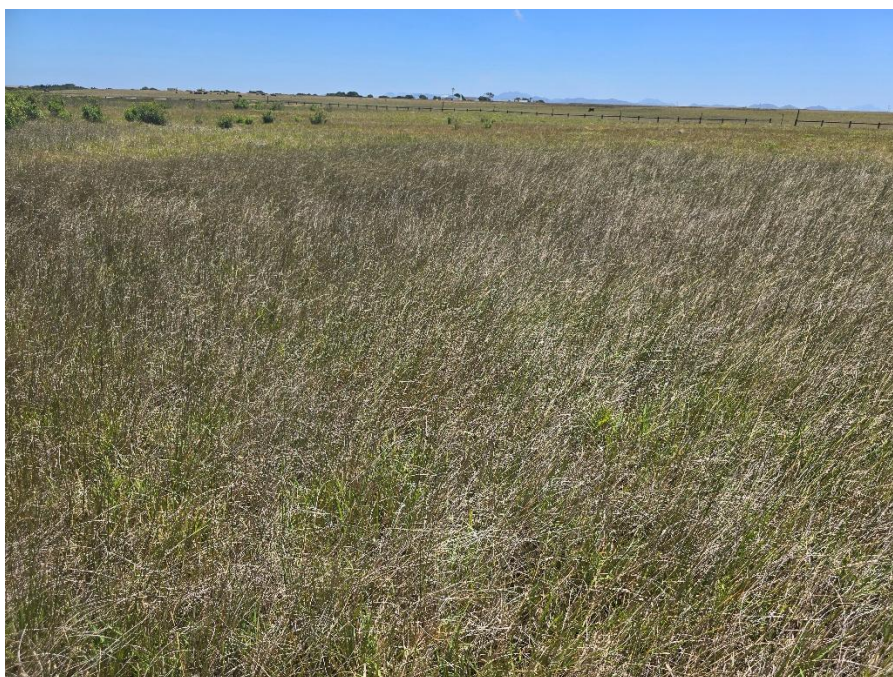
**Figure3.14: Area with vegetation indicating the wetter areas during the wet season – no surface water present.**

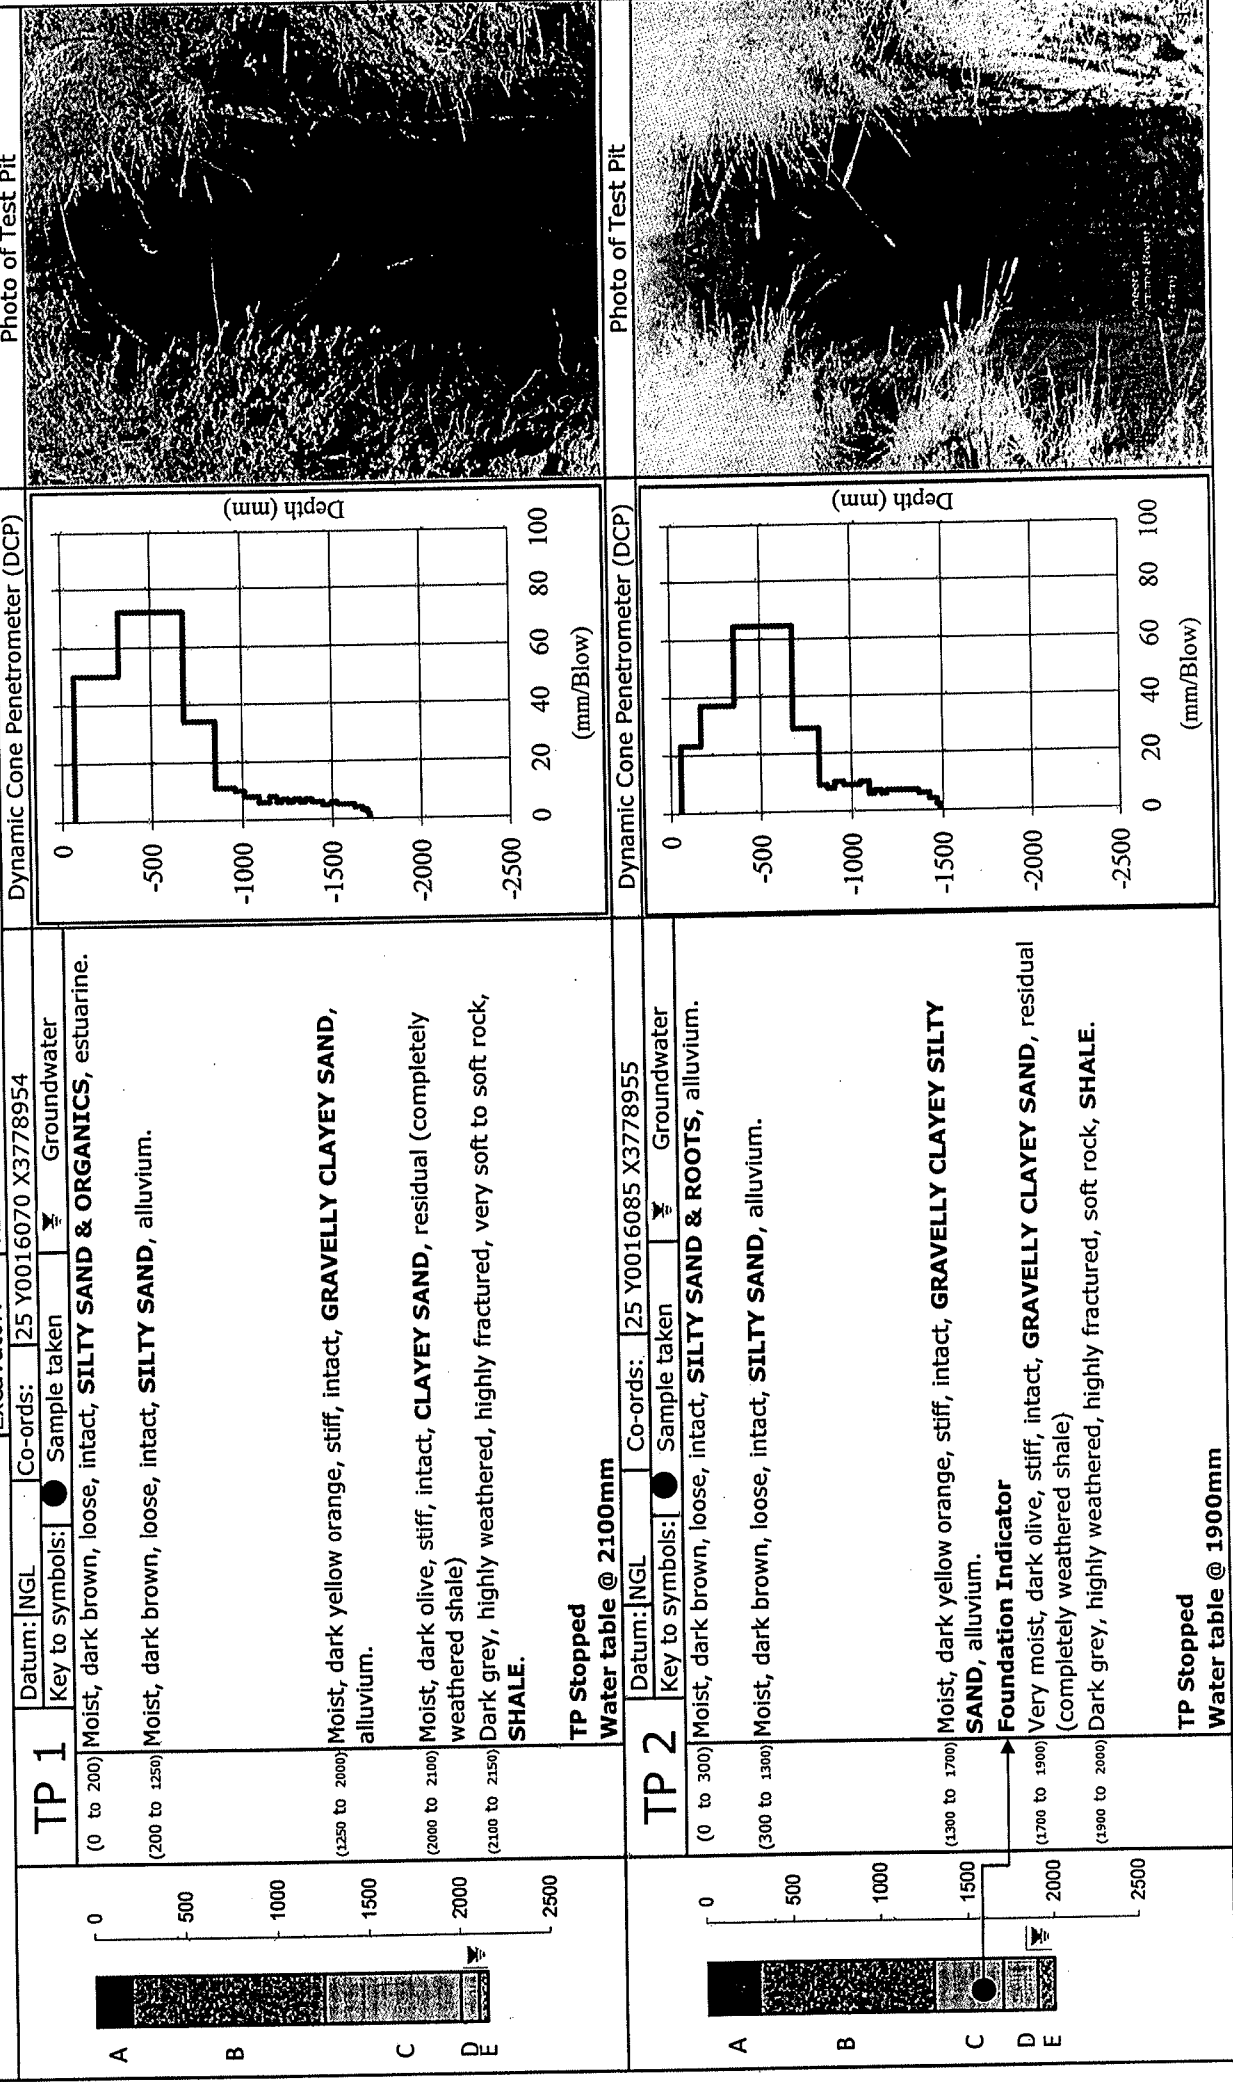
| OUTENIQUA<br>GEOTECHNICAL SERVICES | | | | | Geotechnical Soil Profile | | | | |

A total of five test pits were excavated using a TLB to a maximum depth of ~NGL-2.55m at the positions TP1-4 & TP7, as indicated on the attached plan. DCP tests were conducted from ground level to assess soil consistency at test positions TP1-TP8. A soil sample of insitu material was collected from TP2 for lab tests (Foundation Indicator).

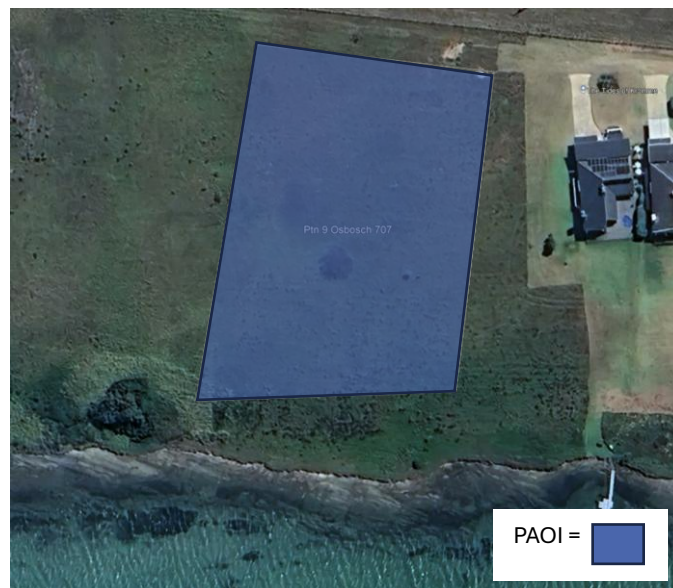
Faunal impacts are therefore expected to be largely confined to the development footprint and its immediate surrounds, and may include temporary habitat disturbance, construction-related noise and vibration, and short-term increases in human activity. Minor indirect effects, such as temporary avoidance behaviour and short-term displacement of mobile fauna, may occur slightly beyond the site boundary but are expected to be localised and reversible. The separation from the riparian zone limits the spatial extent of potential impacts, and the PAOI is considered restricted and site-specific, with no anticipated broader landscape-scale effects.

*Figure 4 Project Area of Influence (PAOI)*

Figure 4 below illustrates the anticipated PAOI.

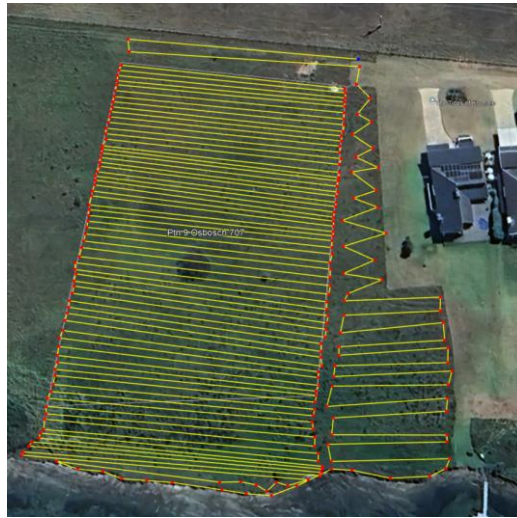
Walking transects 1-3 m apart were conducted to determine the extent of the land portion to identify any sightings and signs of fauna, and potential areas of concern including those identified as "potential sensitive areas" during the desktop assessment. Please refer to Figure 5 below.

*Figure 5 Visual of the transect walked, observing potential SCC or signs thereof.*

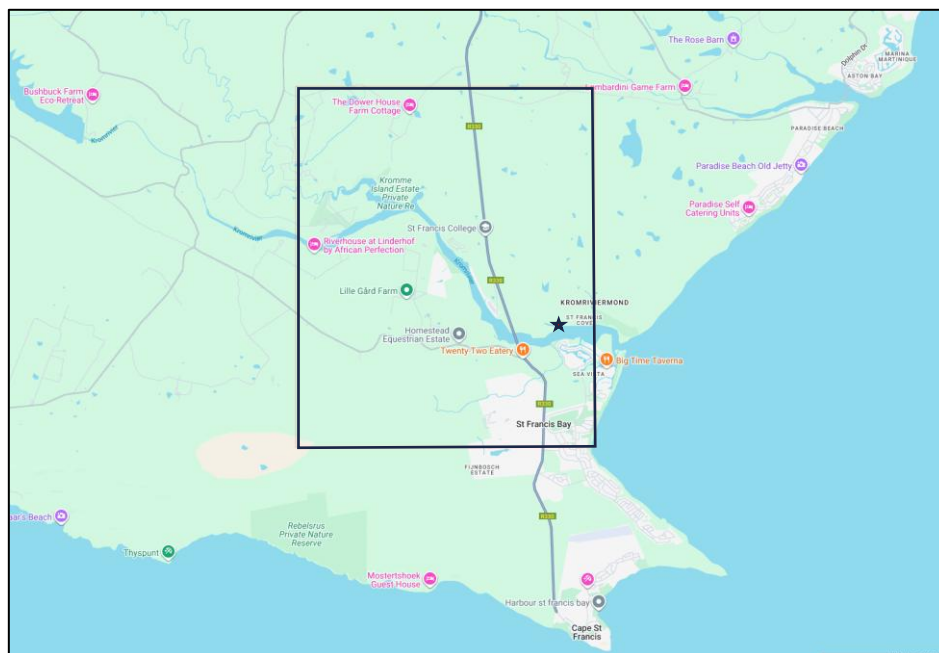
The following list is a total Species of Conservation Concern of the **combined data** from iNaturalist (2026) and the species list obtained from Birdlife SA (2026), based on the Pentad no. 3405\_2445. See below pentad range (Figure 12). For the full list of species recorded in this Pentad, please refer to Annexure B.

Figure 12 Pentad 3405\_2445 (SABAP2, BirdlifeSA, 2026)

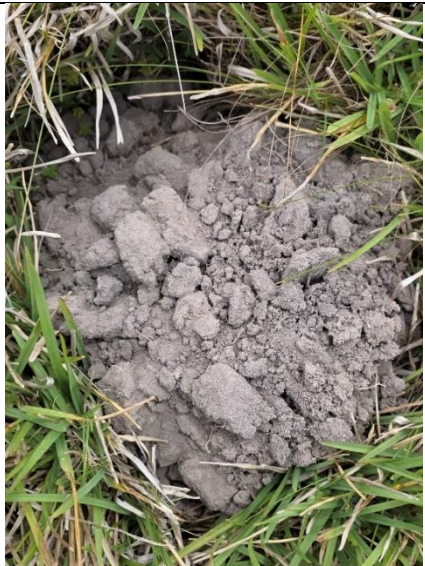
| | | <p>Multiple soil mounds were observed across the entire site indicative of a species of Molerat, most likely the Hottentot Mole Rat (<i>Cryptomus hottentotus</i>).</p> |

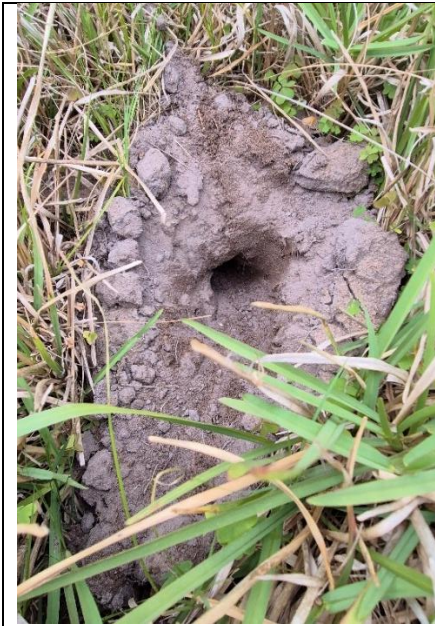
When loose soil was displaced from the mound, a clear burrow approximately 4-5cm wide was observed, indicative of molerats.

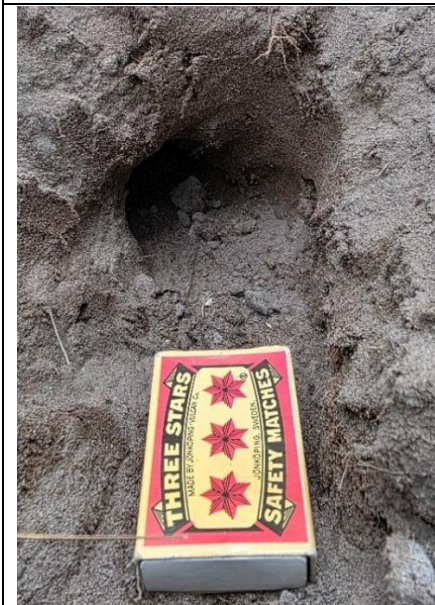
The burrow opening after loose soil was displaced from the soil mound.

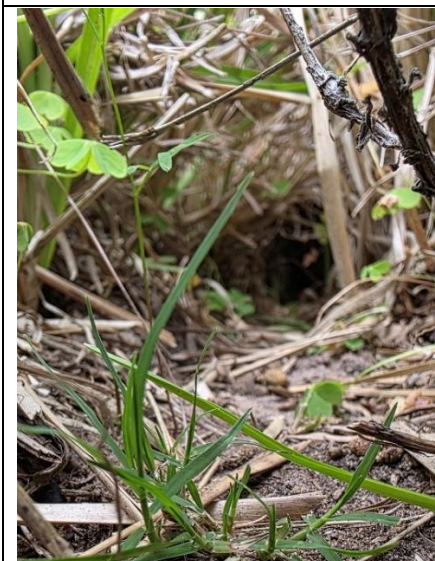
Rodent runways were visible in dense grass.

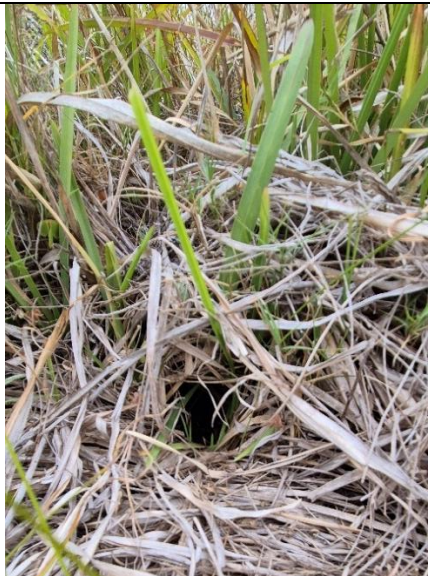
| | | <p>Rodent runway.</p> |

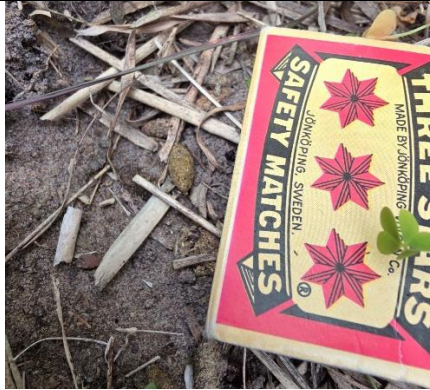
| | | <p>Fecal pellets approximately 5-8mm were found throughout the site, indicative of moles.</p> |

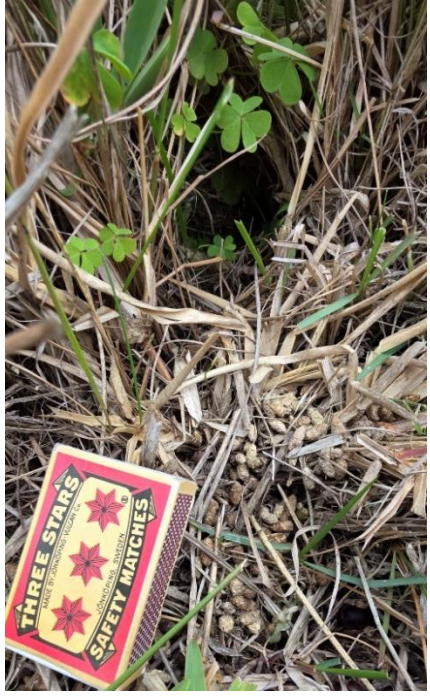
| | | <p>Fecal pellets and rodent runway.</p> |

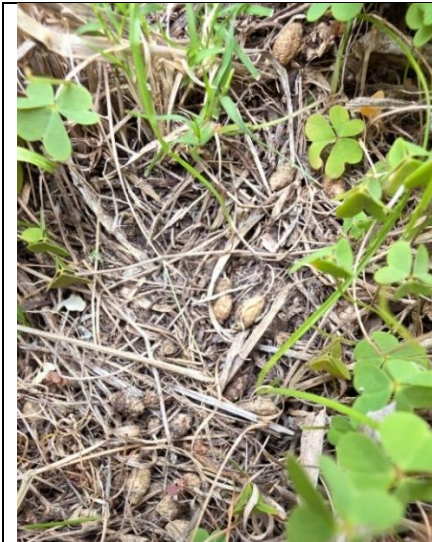
Fecal pellets likely from the Hottentot Molerat.

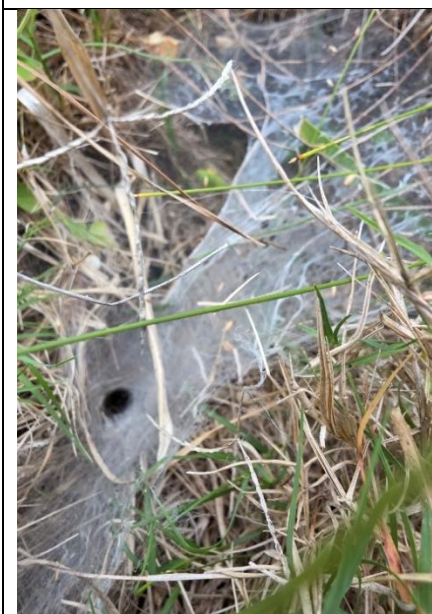
Funnel webs were noted made by spiders most likely from the Agelenidae family.

Numerous grass funnel-web spider (Agelenidae) webs were observed throughout the grassland, indicating suitable habitat conditions for invertebrates. These spiders are common and widespread, with no conservation concern status, and are resilient to moderate habitat disturbance. While some localised loss of individuals may occur within the development footprint, the surrounding grassland will continue to provide suitable habitat, and no long-term impacts on invertebrate populations are anticipated.

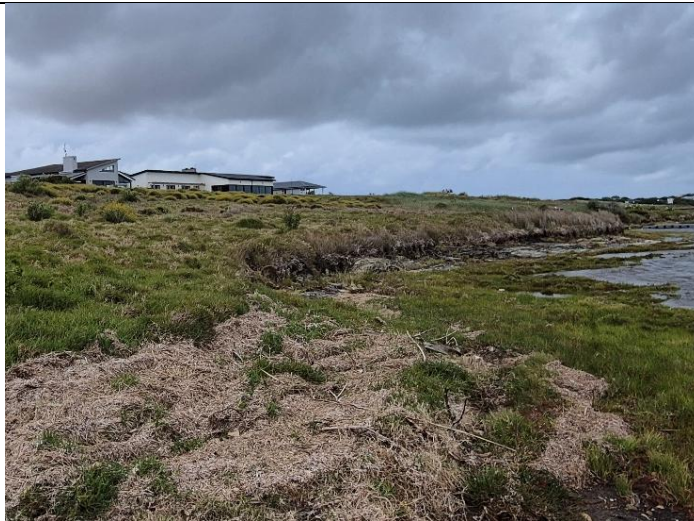
Outside of the southern boundary along the water's edge, there were numerous crustacean burrows along the edge.

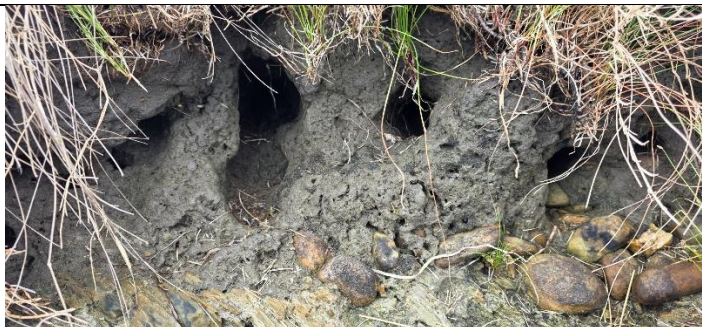
Crustacean burrows, likely made by the Furry Marsh Crab (*Parasesarma catenatum*) (LC).

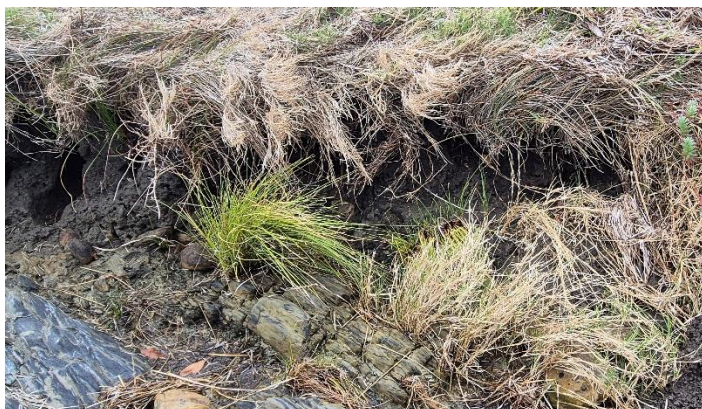
Low crustacean burrows observed along the banks of the Kromme River.

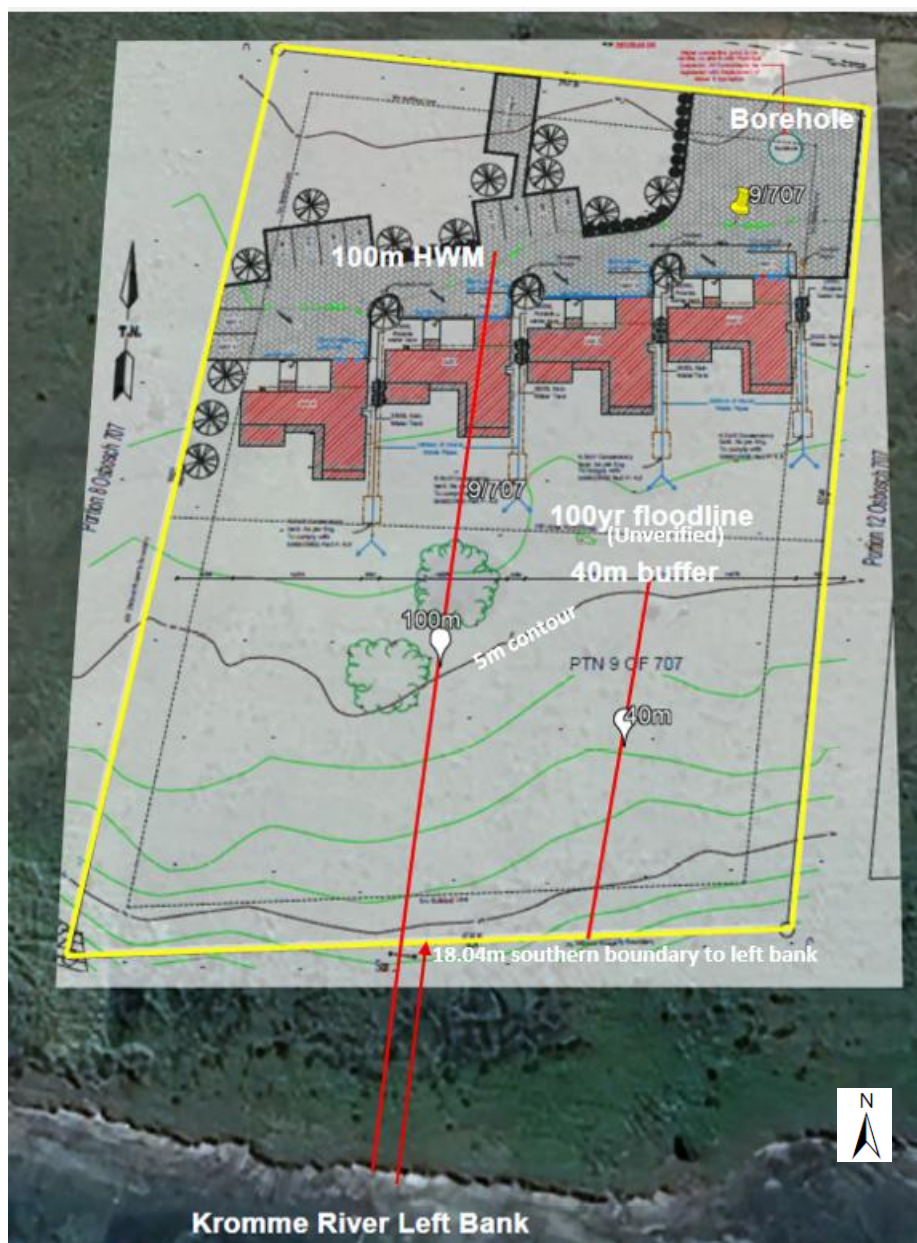
Figure 4 Map illustrating 100m HWM and 100yr floodline on the site

The sensitivity of the site is therefore primarily related to the proximity to the estuary, flood risk areas, and the ecological importance of the surrounding landscape, rather than highly sensitive features located directly within the proposed development footprint. Appropriate environmental management measures must therefore be implemented to ensure that potential impacts on the surrounding estuarine environment are avoided or minimised.

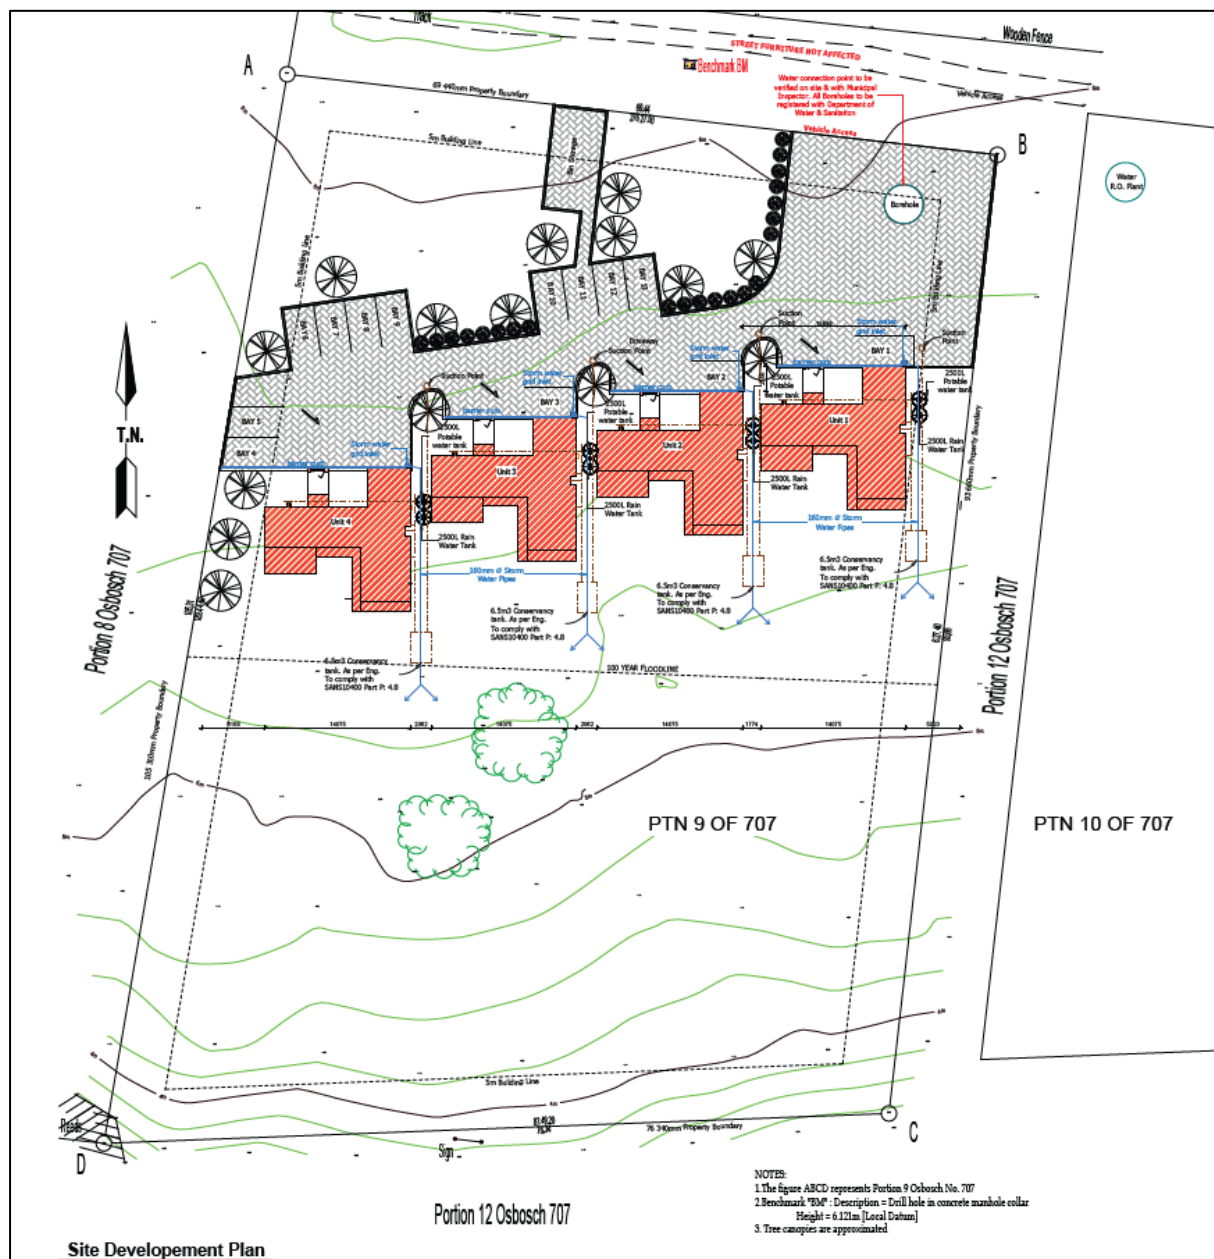
Figure 5 Proposed SDP of the development

The total building coverage of the development represents approximately 6.42% of the site area, while the total site coverage including parking areas is approximately 8.7%, remaining well within the development parameters permitted by the applicable zoning scheme.
